**Flood Control Project Maintenance  
Levee Inspections**

**Fall 2019 Levee Maintenance Deficiency Summary Report**

**Sacramento River Basin**

**Sacramento Maintenance Yard Maintenance Area 0009**

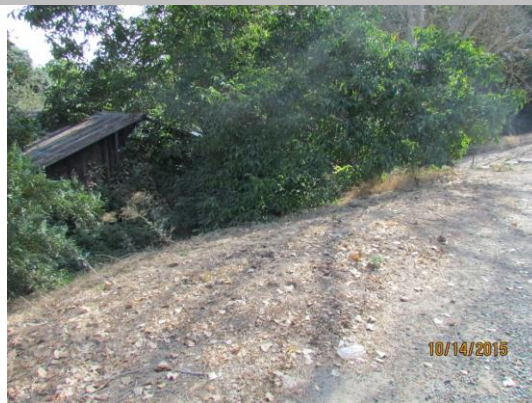
Photo 2 of 2 : FA\_2019\_MA0009\_201\_139\_20190904\_00069.jpg

View of the barn at the levee toe on the landward side of the levee. Trees need to be trimmed for visibility. Fall 2015.

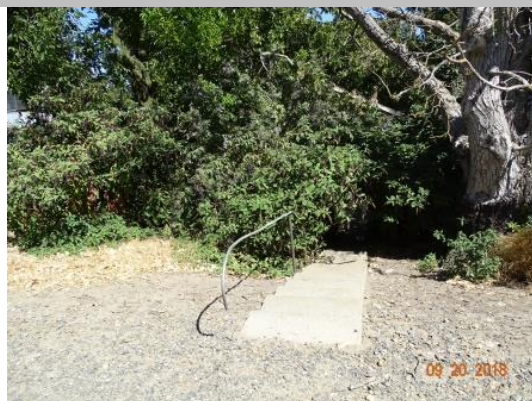
Photo 1 of 3 : FA\_2019\_MA0009\_201\_201\_20190904\_00126.jpg

View of landscaping overgrowth along landside toe. Fall 2018

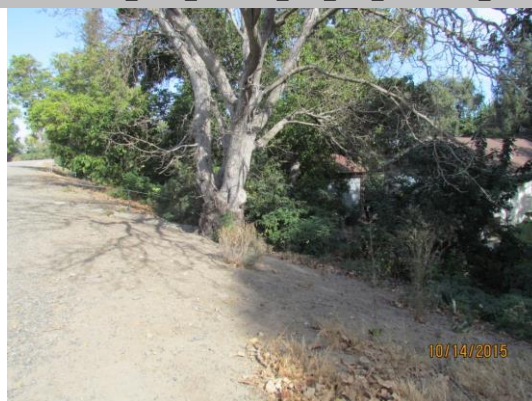
Photo 2 of 3 : FA\_2019\_MA0009\_201\_201\_20190904\_00127.jpg

View of the landscaping at the toe of the levee on the landward side looking upstream. Fall 2015.

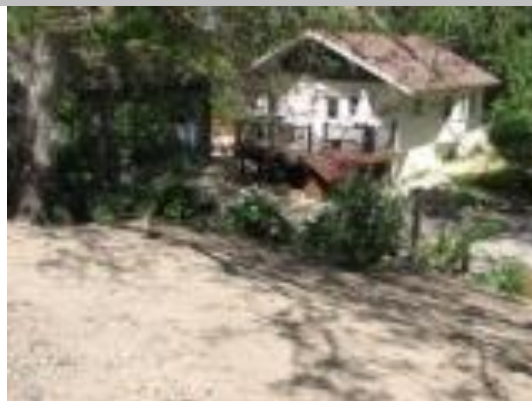
Photo 3 of 3 : FA\_2019\_MA0009\_201\_201\_20190904\_00128.jpg

Shrubs and small trees are being planted on the levee. Spring 2013

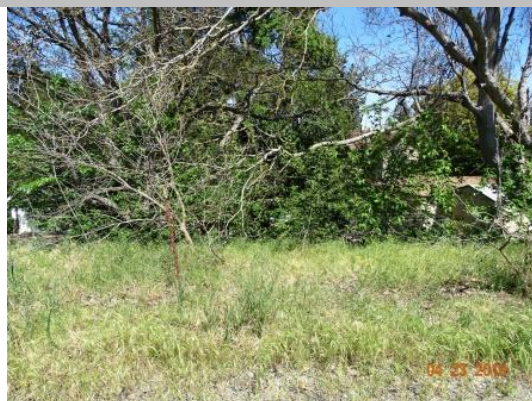
Photo 1 of 3 : FA\_2019\_MA0009\_201\_328\_20190904\_00226.jpg

View of landscaping trees that need to be trimmed. Spring 2019

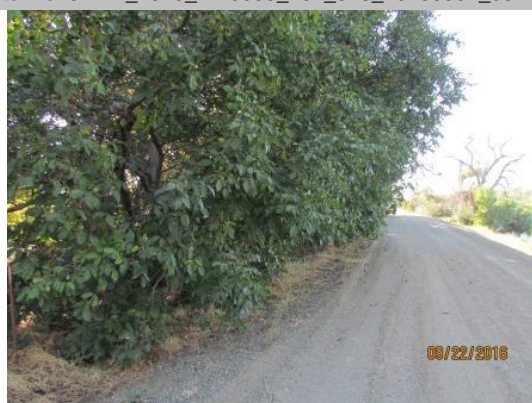
Photo 2 of 3 : FA\_2019\_MA0009\_201\_328\_20190904\_00227.jpg

Trees still need trimming. Fall 2016.

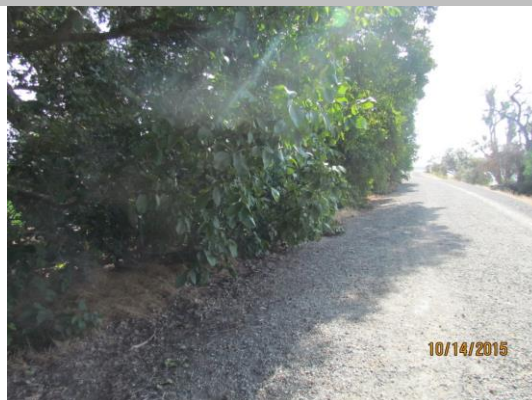
Photo 3 of 3 : FA\_2019\_MA0009\_201\_328\_20190904\_00228.jpg

View of the trees on the landward side of the levee looking downstream. Trees need to be trimmed. Fall 2015.

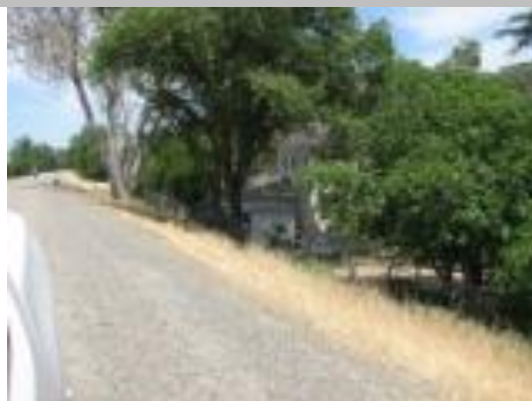
Photo 1 of 2 : FA\_2019\_MA0009\_201\_145\_20190904\_00072.jpg

LM Start	5.25	Rating **	M	Issue No.	145
LM End	5.25	Issue Type +	En	Location *	LS
Category	Earthen Levee			GPS Latitude/Longitude	
				Start	End
Item	Encroachments			38.492442°	38.492442°
				-121.554319°	-121.554319°
DWR ID	DWR_MA0009_01_s_2012_145				
Comment Code					
BU : Building					
Inspector Comment

The building encroaches into the levee.

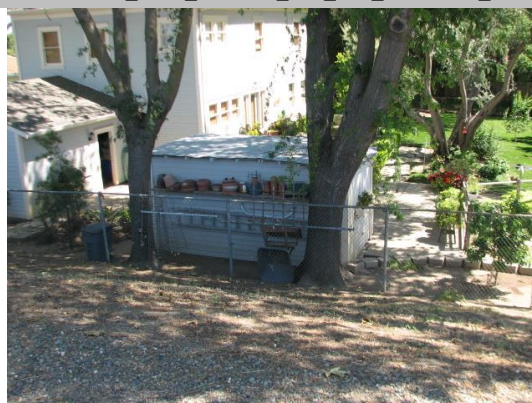
Photo 2 of 2 : FA\_2019\_MA0009\_201\_145\_20190904\_00073.jpg

A garden shed at the toe of the levee. Spring 2014

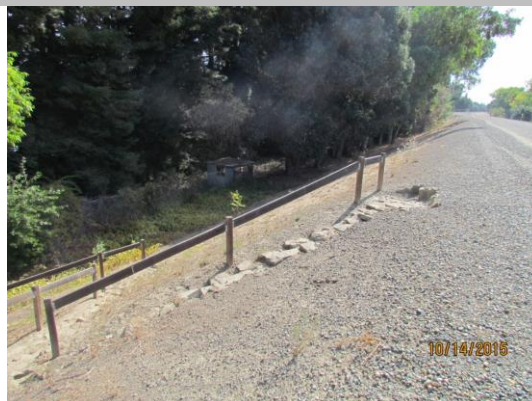
Photo 1 of 1 : FA\_2019\_MA0009\_201\_146\_20190904\_00074.jpg

LM Start	5.28	Rating **	M	Issue No.	146
LM End	5.32	Issue Type +	En	Location *	LS
Category	Earthen Levee			GPS Latitude/Longitude	
				Start	End
Item	Vegetation			38.492132°	38.491623°
				-121.554072°	-121.553634°
DWR ID	DWR_MA0009_01_s_2018_146				
Comment Code					
V6 : Landscaping					
Inspector Comment

View of the landscaping along the toe of the levee on the landward side looking downstream. Fall 2015.

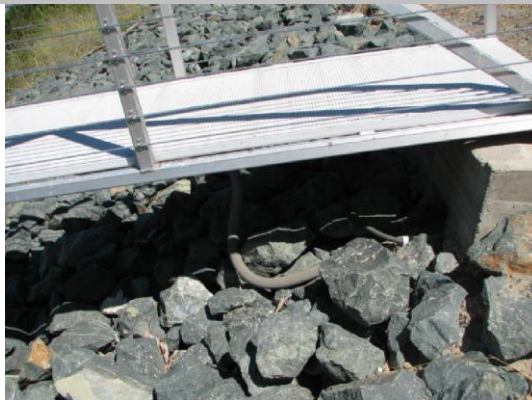
Photo 1 of 2 : UCIP\_FA\_2019\_5900\_8962.jpg

LM Start	5.31	Rating **	M	Issue No.	1791
LM End	5.31	Issue Type +	En	Location *	
Category	Supplemental			GPS Latitude/Longitude	
				Start	End
Item	DRAFT DWR UCIP Field Study			38.491750 °	38.491750 °
				-121.553730 °	-121.553730 °
DWR ID	18943				
Comment Code					
Inspector Comment					
DS_ID:18943 FS_ID:5900 EP_NO: 12922 Repair Type: Non-Urgent Crossing Status: Found UCIP Comments: No permit identified for this crossing. FIELD_STRUCT_DESC: 1 of 2: 2-inch electrical conduit of an unknown material through the levee, at an unknown depth. Conduit located on the downstream side of the boat dock ramp. FS Date: 6/20/2012 2:20:30 PM

Pipes under walkway on WS at ramp.

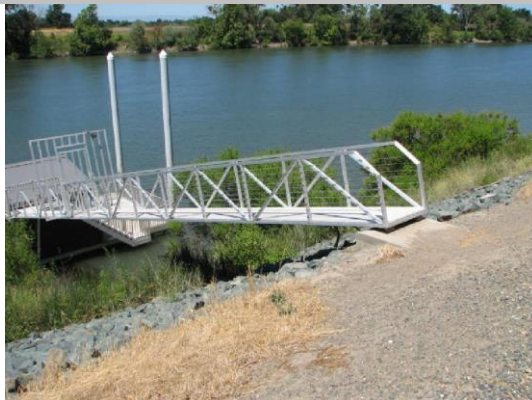
Photo 2 of 2 : UCIP\_FA\_2019\_5900\_8961.jpg

Ramp at WS shoulder.

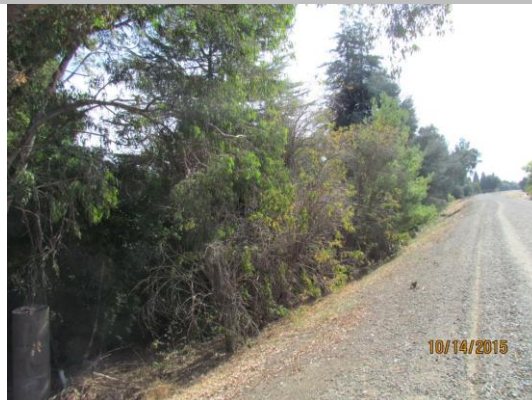
Photo 1 of 2 : FA\_2019\_MA0009\_201\_148\_20190904\_00075.jpg

LM Start	5.34	Rating **	U	Issue No.	148
LM End	5.38	Issue Type +	En	Location *	LS
Category	Earthen Levee			GPS Latitude/Longitude	
				Start	End
Item	Vegetation			38.491357 °	38.490897 °
				-121.553393 °	-121.552974 °
DWR ID	DWR_MA0009_01_s_2012_148				
Comment Code					
V6 : Landscaping					
Inspector Comment					
Landscaping blocks visibility of levee slopes.

View of the landscaping along the levee slope on the landward side looking downstream. Fall 2015.

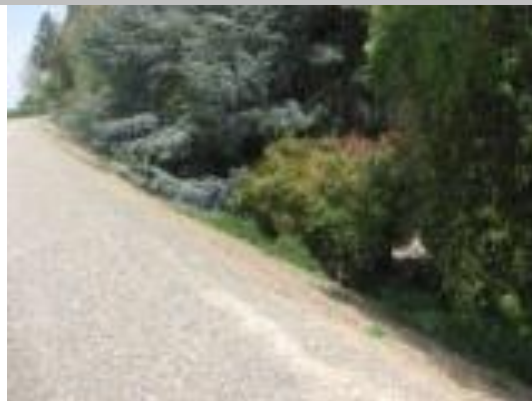
Photo 2 of 2 : FA\_2019\_MA0009\_201\_148\_20190904\_00076.jpg

The cedar tree covers the levee slope blocks visibility. Photo taken spring 2012.

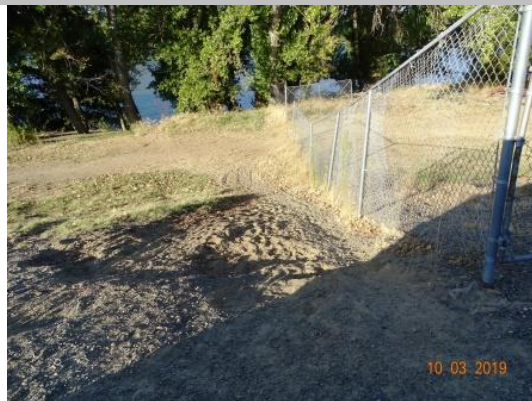
Photo 1 of 1 : FA\_2019\_MA0009\_201\_191\_20191008\_00523.jpg

View of slope damage by vehicle and/or foot traffic. The private gate at the toe was left open. Fall 2019

LM Start	5.46	Rating **	M	Issue No.	191
LM End	5.46	Issue Type +	Ma	Location *	WS
Category	Earthen Levee			GPS Latitude/Longitude	
				Start	End
Item	Slope Stability			38.489988 °	38.489988 °
				-121.552132 °	-121.552132 °
DWR ID	DWR_MA0009_01_f_2019_191				
Comment Code					
S3 : Repair the levee slope damaged by vehicle traffic and prevent access where possible.					
Inspector Comment					
The fence at the waterside toe needs to remain locked to prevent private vehicle access.

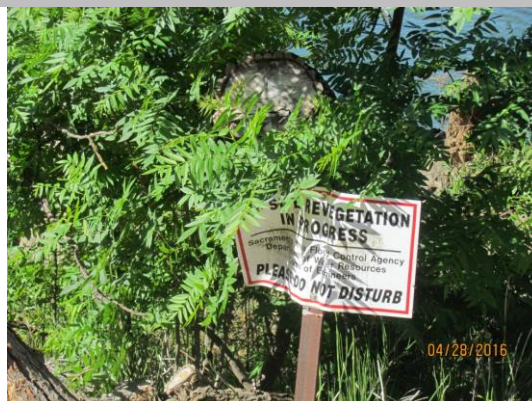
Photo 1 of 2 : FA\_2019\_MA0009\_201\_132\_20190904\_00059.jpg

LM Start	5.49	Rating **	A/W	Issue No.	132
LM End	5.93	Issue Type +	En	Location *	WS
Category	Earthen Levee			GPS Latitude/Longitude	
				Start	End
Item	Vegetation			38.489589 °	38.484026 °
				-121.551825 °	-121.547831 °
DWR ID	DWR_MA0009_01_s_2012_132				
Comment Code					
V8 : Environmental Requirements.					
Inspector Comment

Sign stating the revegetation site. Spring 2016.

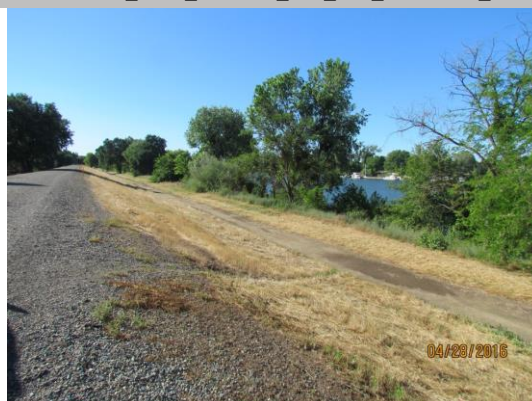
Photo 2 of 2 : FA\_2019\_MA0009\_201\_132\_20190904\_00060.jpg

View of the revegetation site on the waterward berm of the levee looking downstream. Spring 2016.

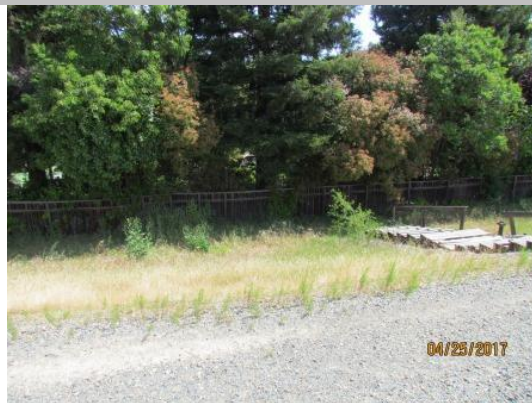
Photo 1 of 2 : FA\_2019\_MA0009\_201\_152\_20190904\_00080.jpg

LM Start	5.50	Rating **	U	Issue No.	152
LM End	5.50	Issue Type +	En	Location *	LS
Category	Earthen Levee			GPS Latitude/Longitude	
				Start	End
Item	Encroachments			38.489427 °	38.489427 °
				-121.551715 °	-121.551715 °
DWR ID	DWR_MA0009_01_f_2017_152				
Comment Code					
FE : Fence					
Inspector Comment					
The wooden fence does not appear to be authorized.

View of fence at landside levee toe. Spring 2017.

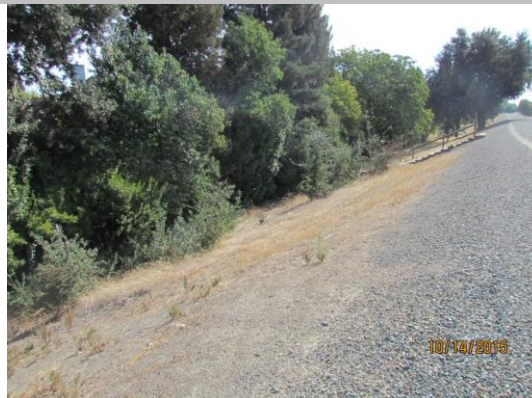
Photo 2 of 2 : FA\_2019\_MA0009\_201\_152\_20190904\_00081.jpg

LM Start	5.50	Rating **	U	Issue No.	152 (cont)	
LM End	5.50	Issue Type +	En	Location *	LS	
Category	Earthen Levee			GPS Latitude/Longitude		
				Start		End
Item	Encroachments			38.489427 °	38.489427 °	
				-121.551715 °	-121.551715 °	
DWR ID	DWR_MA0009_01_f_2017_152					
Comment Code						
FE : Fence						
Inspector Comment						
The wooden fence does not appear to be authorized.

View of the landscaping at the toe of the levee on the landward side looking downstream. Fall 2015.

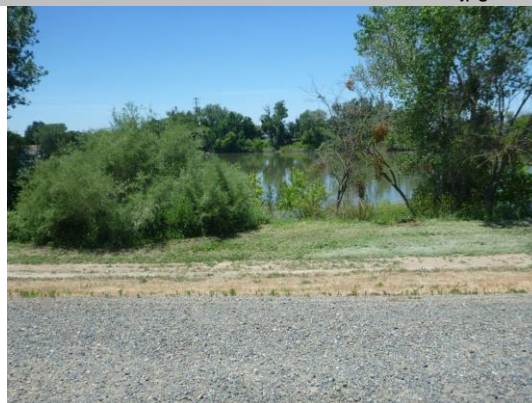
Photo 1 of 3 : LEVAL\_FA\_2019\_233\_451.jpg

LM Start	5.52	Rating **	A/W	Issue No.	238	
LM End	5.52	Issue Type +	Ma	Location *		
Category	Supplemental			GPS Latitude/Longitude		
				Start	End	
Item	2017 Storm Damage			38.489231	°	38.489179
				-121.551502	°	-121.551473
DWR ID	LMA-66					
Comment Code						
Inspector Comment						
Levee Evaluation Comments						
Description:						
Site ID No:233						
Site Designation:LMA-66						
Repair Type: Erosion						
Rating:Area of Concern						
Field Date:2/10/2017						
Notes: existing riparian scrub

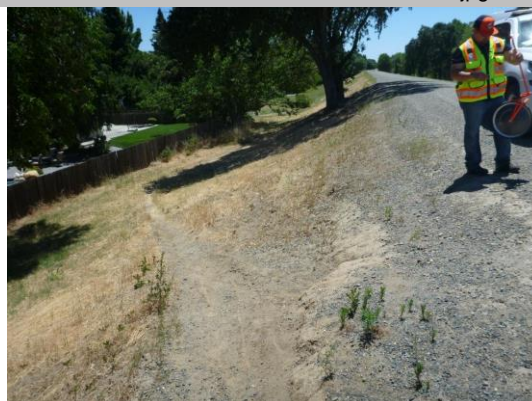
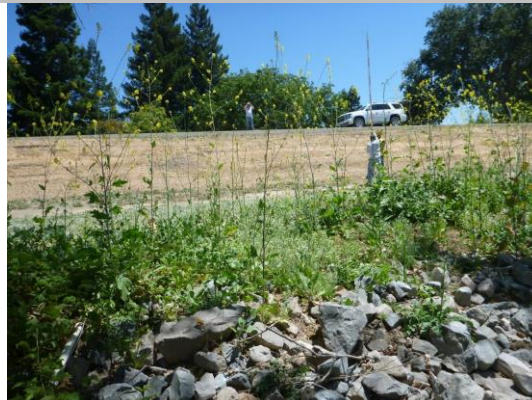
LM Start	5.52	Rating **	A/W	Issue No.	238 (cont)	
LM End	5.52	Issue Type +	Ma	Location *		
Category	Supplemental			GPS Latitude/Longitude		
				Start		End
Item	2017 Storm Damage			38.489231 °	38.489179 °	
				-121.551502 °	-121.551473 °	
DWR ID	LMA-66					
Comment Code						
Inspector Comment						
Levee Evaluation Comments						
Description:						
Site ID No:233						
Site Designation:LMA-66						
Repair Type: Erosion						
Rating:Area of Concern						
Field Date:2/10/2017						
Notes: existing riparian scrub

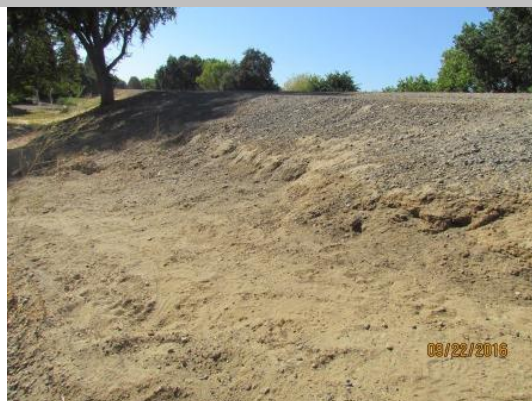
Photo 1 of 2 : FA\_2019\_MA0009\_201\_358\_20190904\_00251.jpg

LM Start	5.53	Rating **	M	Issue No.	358
LM End	5.53	Issue Type +	Ma	Location *	LS
Category	Earthen Levee			GPS Latitude/Longitude	
				Start	End
Item	Slope Stability			38.489152°	38.489152°
				-121.551452°	-121.551452°
DWR ID	DWR_MA0009_01_s_2016_358				
Comment Code					
S3 : Repair the levee slope damaged by vehicle traffic and prevent access where possible.					
Inspector Comment

View of the site on LS of the levee looking downstream. Fall 2016.

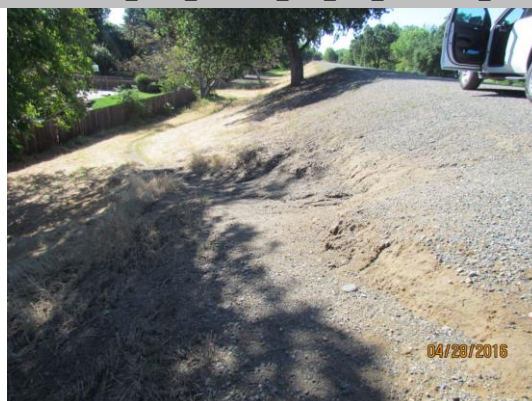
Photo 2 of 2 : FA\_2019\_MA0009\_201\_358\_20190904\_00252.jpg

View of the slope stability on the landward side of the levee looking downstream. Spring 2016.

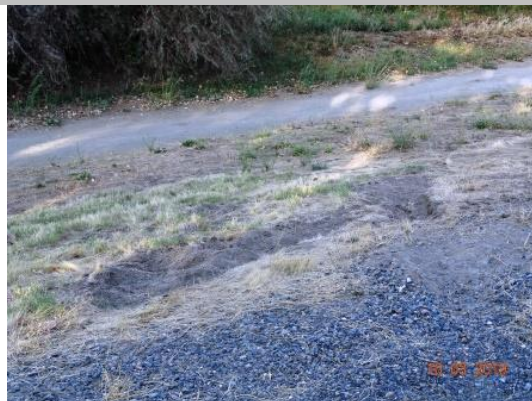
Photo 1 of 1 : FA\_2019\_MA0009\_201\_189\_20191008\_00522.jpg

LM Start	5.53	Rating **	M	Issue No.	189
LM End	5.53	Issue Type +	Ma	Location *	WS
Category	Earthen Levee			GPS Latitude/Longitude	
				Start	End
Item	Slope Stability			38.489112°	38.489112°
				-121.551467°	-121.551467°
DWR ID	DWR_MA0009_01_f_2019_189				
Comment Code					
S3 : Repair the levee slope damaged by vehicle traffic and prevent access where possible.					
Inspector Comment

View of tire track damage on waterside slope. Fall 2019

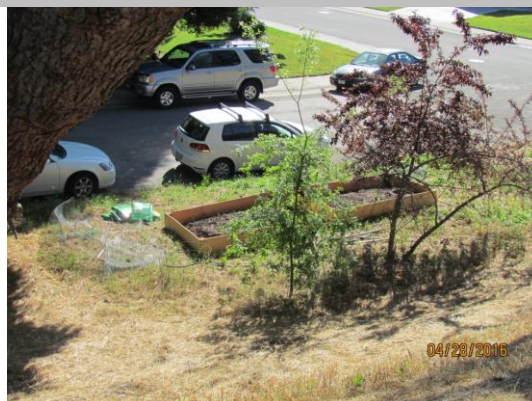
Photo 1 of 2 : FA\_2019\_MA0009\_201\_367\_20190904\_00261.jpg

LM Start	5.83	Rating **	M	Issue No.	367
LM End	5.83	Issue Type +	En	Location *	LS
Category	Earthen Levee			GPS Latitude/Longitude	
				Start	End
Item	Vegetation			38.485295 °	38.485295 °
				-121.548628 °	-121.548628 °
DWR ID	DWR_MA0009_01_s_2016_367				
Comment Code					
V6 : Landscaping					
Inspector Comment					
Small garden starting at the berm of the levee. Tree debris also left onsite.

A garden is on the berm of the levee on the landward side. Spring 2016.

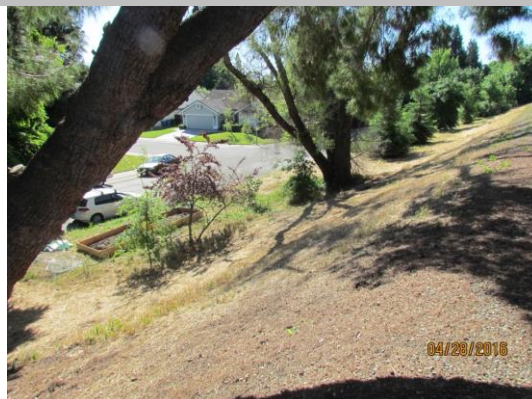
Photo 2 of 2 : FA\_2019\_MA0009\_201\_367\_20190904\_00262.jpg

View of the garden looking downstream. Spring 2016.

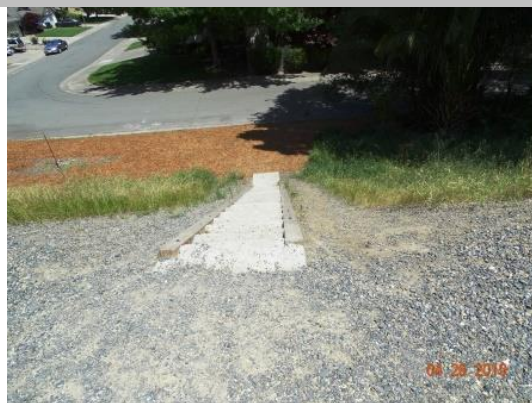
Photo 1 of 1 : FA\_2019\_MA0009\_201\_651\_20190904\_00301.jpg

LM Start	5.91	Rating **	M	Issue No.	651
LM End	5.91	Issue Type +	En	Location *	LS
Category	Earthen Levee			GPS Latitude/Longitude	
				Start	End
Item	Encroachments			38.484297 °	38.484297 °
				-121.547982 °	-121.547982 °
DWR ID	DWR_MA0009_01_s _ 2019_651				
Comment Code					
ST : Stairway					
Inspector Comment					
Concrete and wooden staircase is not permitted.

View of concrete and wooden staircase on levee slope. Spring 2019

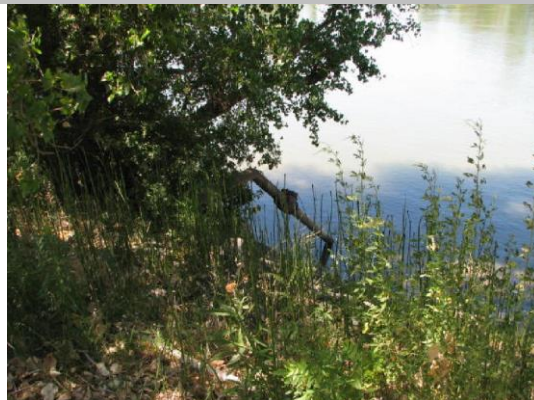
Photo 1 of 3 : UCIP\_FA\_2019\_4980\_6630.jpg

LM Start	5.93	Rating **	M	Issue No.	1793
LM End	5.93	Issue Type +	En	Location *	
Category	Supplemental			GPS Latitude/Longitude	
				Start	End
Item	DRAFT DWR UCIP Field Study			38.484130 °	38.484130 °
				-121.547854 °	-121.547854 °
DWR ID	17425				
Comment Code					
Inspector Comment					
DS_ID:17425 FS_ID:4980 EP_NO: N/A Repair Type: Non-Urgent Crossing Status: Found UCIP Comments: Pipe has holes at welds on WS near bend in pipe. This pipe appears to be abandoned so it may need to be removed or grouted in place. FIELD_STRUCT_DESC: 8-inch concrete encased pipe through the levee, 4.9 feet below the crown. Pump in pump house on waterward slope, Siphon breaker in C.M riser on landward slope have been removed. Originally included in O+M manual (1955). FS Date: 6/20/2012 12:55:36 PM

Pipe entering water at WS toe

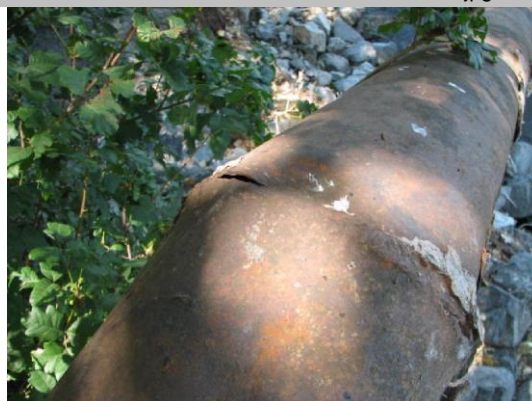
Photo 3 of 3 : UCIP\_FA\_2019\_4980\_6628.jpg

LM Start	5.93	Rating **	M	Issue No.	1793 (cont)	
LM End	5.93	Issue Type +	En	Location *		
Category	Supplemental			GPS Latitude/Longitude		
				Start	End	
Item	DRAFT DWR UCIP Field Study			38.484130 °	38.484130 °	
				-121.547854 °	-121.547854 °	
DWR ID	17425					
Comment Code						
Inspector Comment						
DS_ID:17425 FS_ID:4980 EP_NO: N/A Repair Type: Non-Urgent Crossing Status: Found UCIP Comments: Pipe has holes at welds on WS near bend in pipe. This pipe appears to be abandoned so it may need to be removed or grouted in place. FIELD_STRUCT_DESC: 8-inch concrete encased pipe through the levee, 4.9 feet below the crown. Pump in pump house on waterward slope, Siphon breaker in C.M riser on landward slope have been removed. Originally included in O+M manual (1955). FS Date: 6/20/2012 12:55:36 PM

small holes in pipe along welded seam.

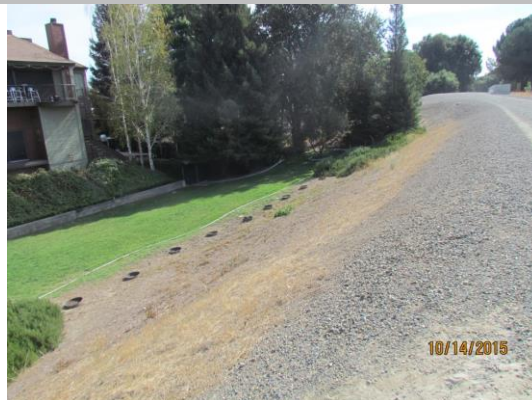
Photo 1 of 1 : FA\_2019\_MA0009\_201\_155\_20190904\_00083.jpg

LM Start	5.96	Rating **	M	Issue No.	155
LM End	5.99	Issue Type +	En	Location *	LS
Category	Earthen Levee			GPS Latitude/Longitude	
				Start	End
Item	Vegetation			38.483639 °	38.483310 °
				-121.547532 °	-121.547297 °
DWR ID	DWR_MA0009_01_s_2012_155				
Comment Code					
V6 : Landscaping					
Inspector Comment

View of the garden on the landward side of the levee looking downhill.  
Fall 2015.

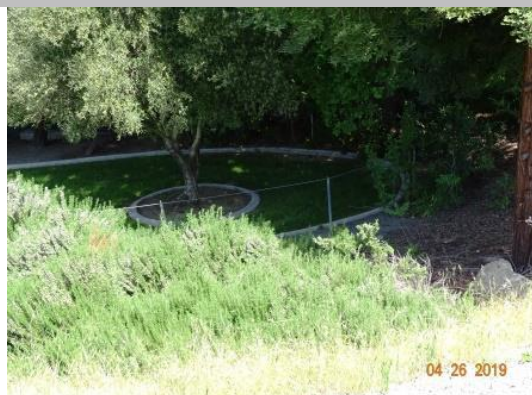
Photo 1 of 1 : FA\_2019\_MA0009\_201\_652\_20190904\_00302.jpg

LM Start	5.99	Rating **	M	Issue No.	652
LM End	5.99	Issue Type +	En	Location *	LS
Category	Earthen Levee			GPS Latitude/Longitude	
				Start	End
Item	Encroachments			38.483292 °	38.483292 °
				-121.547257 °	-121.547257 °
DWR ID	DWR_MA0009_01_s _ 2019_652				
Comment Code					
FE : Fence					
Inspector Comment					
Metal post fence is unpermitted.

View of metal post and cable fence at the levee toe. Spring 2019

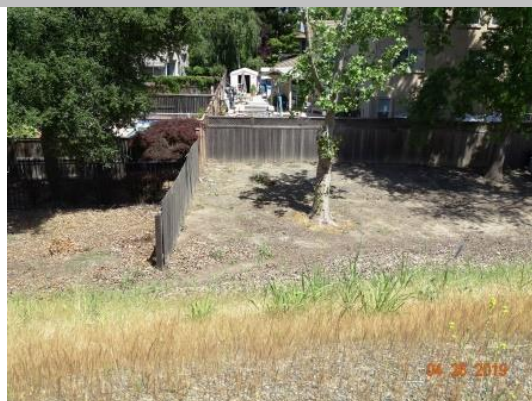
Photo 1 of 1 : FA\_2019\_MA0009\_201\_653\_20190904\_00303.jpg

LM Start	6.11	Rating **	M	Issue No.	653
LM End	6.11	Issue Type +	En	Location *	LS
Category	Earthen Levee			GPS Latitude/Longitude	
				Start	End
Item	Encroachments			38.481767°	38.481767°
				-121.546092°	-121.546092°
DWR ID	DWR_MA0009_01_s_2019_653				
Comment Code					
FE : Fence					
Inspector Comment					
Wooden fence extends into levee easement.

View of wooden fence that extends into levee easement. Spring 2019

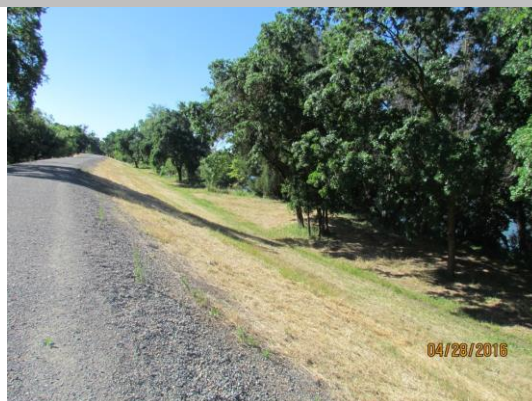
Photo 1 of 2 : FA\_2019\_MA0009\_201\_134\_20190904\_00061.jpg

LM Start	6.13	Rating **	A/W	Issue No.	134
LM End	6.25	Issue Type +	En	Location *	WS
Category	Earthen Levee			GPS Latitude/Longitude	
				Start	End
Item	Vegetation			38.481560 °	38.480129 °
				-121.545850 °	-121.544858 °
DWR ID	DWR_MA0009_01_s_2012_134				
Comment Code					
V8 : Environmental Requirements.					
Inspector Comment

View of the revegetation site on the berm of the waterward side of the levee looking downstream. Spring 2016.

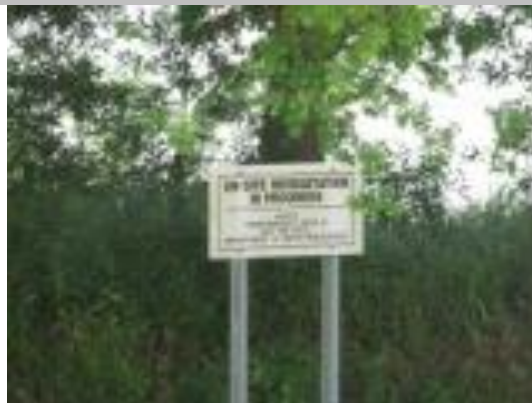
Photo 2 of 2 : FA\_2019\_MA0009\_201\_134\_20190904\_00062.jpg

A revegetation site. Photo taken spring 2012.

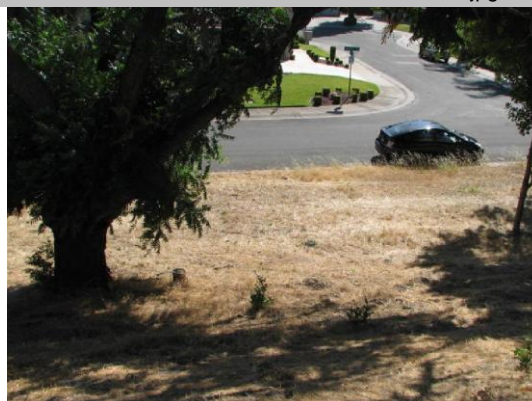
Photo 1 of 1 : UCIP\_FA\_2019\_41067\_6688.jpg

LM Start	6.16	Rating **	M	Issue No.	1794
LM End	6.16	Issue Type +	En	Location *	
Category	Supplemental			GPS Latitude/Longitude	
				Start	End
Item	DRAFT DWR UCIP Field Study			38.481270 °	38.481270 °
				-121.545630 °	-121.545630 °
DWR ID	17379				
Comment Code					
Inspector Comment					
DS_ID:17379 FS_ID:41067 EP_NO: N/A Repair Type: Non-Urgent Crossing Status: Indicator Found UCIP Comments: remains of a cut off telephone pole 50-feet downstream from this location may be good indicator of abandoned pipe location. FIELD_STRUCT_DESC: 6-inch pipe through the levee approximately 17-feet below the crown. Constructed with 1-cm cut-off wall and pump and check valve on river side. Pipe has been plugged and abandoned in place 10/31/89. Originally included in O+M manual (1955). FS Date: 6/21/2012 3:50:00 PM

Sawed off power pole at LS toe 50-feet Downstream from pipe location may be good indicator of Abandoned pipe location.

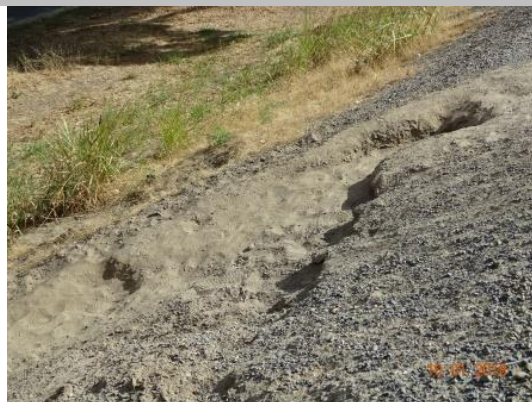
Photo 1 of 4 : FA\_2019\_MA0009\_201\_249\_20190904\_00171.jpg

LM Start	6.24	Rating **	A/W	Issue No.	249
LM End	6.24	Issue Type +	Ma	Location *	
Category	Supplemental			GPS Latitude/Longitude	
				Start	End
Item	2017 Storm Damage			38.480251 °	38.480199 °
				-121.544900 °	-121.544865 °
DWR ID	LMA-67				
Comment Code					
Inspector Comment					
Levee Evaluation Comments					
Description:					
Site ID No:234					
Site Designation:LMA-67					
Repair Type: Erosion					
Rating:Area of Concern					
Field Date:6/2/2017					
Notes: Footpath on landside slope.

View of slope damage along landside slope. Fall 2018

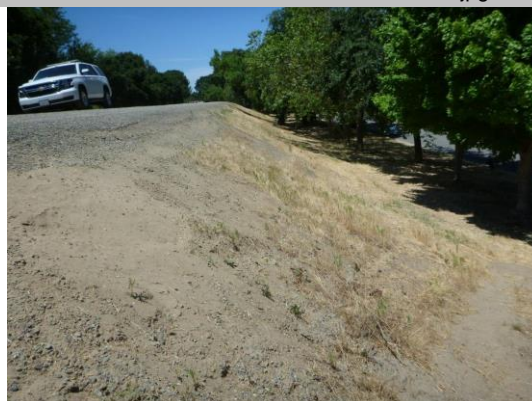
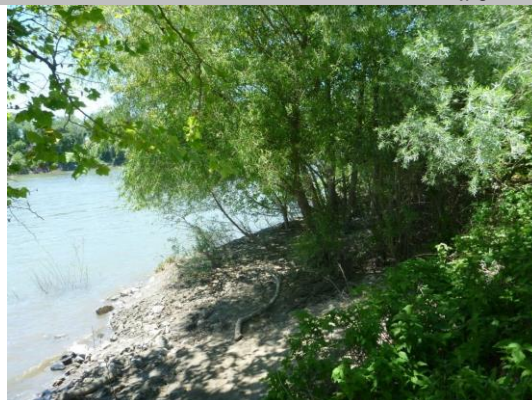
LM Start	6.24	Rating **	A/W	Issue No.	249 (cont)	
LM End	6.24	Issue Type +	Ma	Location *		
Category	Supplemental			GPS Latitude/Longitude		
				Start	End	
Item	2017 Storm Damage			38.480251 °	38.480199 °	
				-121.544900 °	-121.544865 °	
DWR ID	LMA-67					
Comment Code						
Inspector Comment						
Levee Evaluation Comments						
Description:						
Site ID No:234						
Site Designation:LMA-67						
Repair Type: Erosion						
Rating:Area of Concern						
Field Date:6/2/2017						
Notes: Footpath on landside slope.

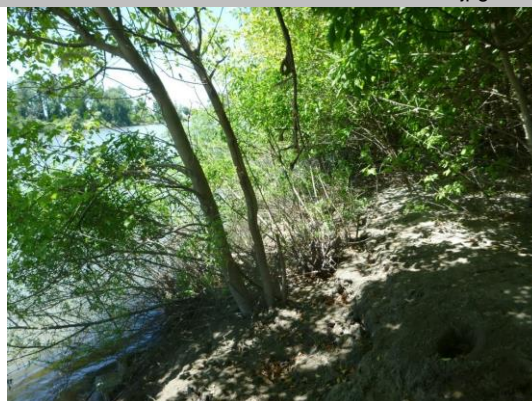
Photo 4 of 4 : LEVAL\_FA\_2019\_234\_608.jpg

LM Start	6.24	Rating **	A/W	Issue No.	249 (cont)	
LM End	6.24	Issue Type +	Ma	Location *		
Category	Supplemental			GPS Latitude/Longitude		
				Start		End
Item	2017 Storm Damage			38.480251	°	38.480199
				-121.544900	°	-121.544865
DWR ID	LMA-67					
Comment Code						
Inspector Comment						
Levee Evaluation Comments						
Description:						
Site ID No:234						
Site Designation:LMA-67						
Repair Type: Erosion						
Rating:Area of Concern						
Field Date:6/2/2017						
Notes: Footpath on landside slope.

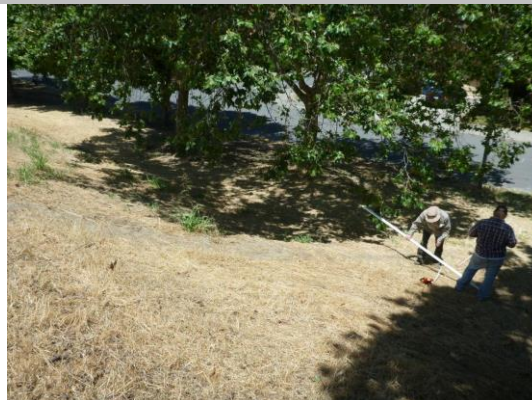
Photo 1 of 3 : LEVAL\_FA\_2019\_235\_801.jpg

LM Start	6.25	Rating **	A/W	Issue No.	250	
LM End	6.25	Issue Type +	Ma	Location *	LS	
Category	Supplemental			GPS Latitude/Longitude		
				Start		End
Item	2017 Storm Damage			38.480124	°	38.480099
				-121.544812	°	-121.544795
DWR ID	LMA-68					
Comment Code						
Inspector Comment						
Levee Evaluation Comments						
Description:						
Site ID No:235						
Site Designation:LMA-68						
Repair Type: Erosion						
Rating: Area of Concern						
Field Date:6/6/2017						
Notes: Erosion on existing landside footpaths.

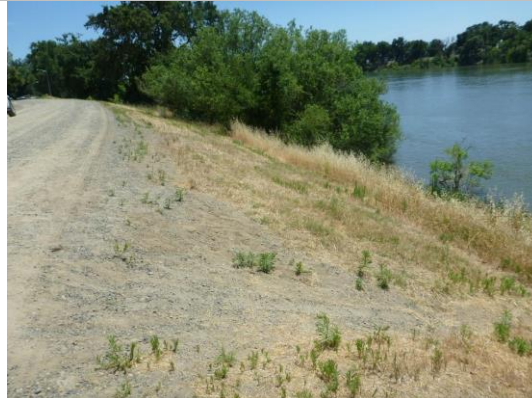
Photo 2 of 3 : LEVAL\_FA\_2019\_235\_807.jpg

LM Start	6.25	Rating **	A/W	Issue No.	250 (cont)	
LM End	6.25	Issue Type +	Ma	Location *	LS	
Category	Supplemental			GPS Latitude/Longitude		
				Start		End
Item	2017 Storm Damage			38.480124 °		38.480099 °
				-121.544812 °		-121.544795 °
DWR ID	LMA-68					
Comment Code						
Inspector Comment						
Levee Evaluation Comments						
Description:						
Site ID No:235						
Site Designation:LMA-68						
Repair Type: Erosion						
Rating: Area of Concern						
Field Date:6/6/2017						
Notes: Erosion on existing landside footpaths.

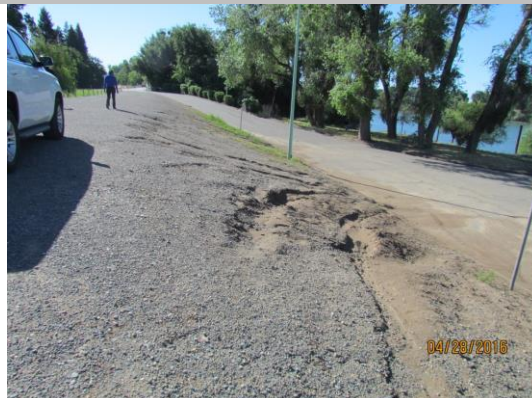
Photo 2 of 2 : FA\_2019\_MA0009\_201\_375\_20190904\_00267.jpg

LM Start	6.37	Rating **	M	Issue No.	375 (cont)
LM End	6.37	Issue Type +	Ma	Location *	WS
Category	Earthen Levee			GPS Latitude/Longitude	
				Start	End
Item	Slope Stability			38.478698 °	38.478698 °
				-121.543333 °	-121.543333 °
DWR ID	DWR_MA0009_01_s_2016_375				
Comment Code					
S2 : Repair the levee slope damaged by foot traffic and prevent access where possible.					
Inspector Comment

View of the slope stability on the waterward side of the levee looking downstream. Spring 2016.

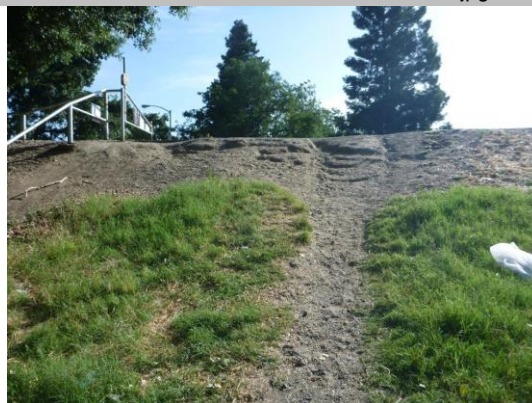
Photo 1 of 3 : LEVAL\_FA\_2019\_236\_815.jpg

LM Start	6.43	Rating **	M	Issue No.	266
LM End	6.44	Issue Type +	Ma	Location *	
Category	Supplemental			GPS Latitude/Longitude	
				Start	End
Item	2017 Storm Damage			38.478089 °	38.478050 °
				-121.542623 °	-121.542581 °
DWR ID	LMA-69				
Comment Code					
Inspector Comment					
Levee Evaluation Comments					
Description:					
Site ID No:236					
Site Designation:LMA-69					
Repair Type: Erosion					
Rating: Area of Concern					
Field Date:6/7/2017					
Notes: upper waterside levee slope erosion appeared caused from runoff from paved crown and foot traffic

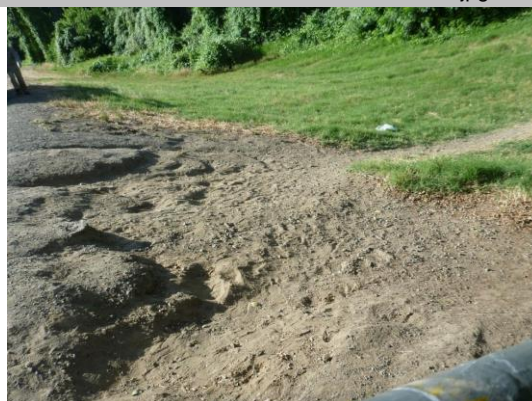
Photo 2 of 3 : LEVAL\_FA\_2019\_236\_820.jpg

LM Start	6.43	Rating **	M	Issue No.	266 (cont)	
LM End	6.44	Issue Type +	Ma	Location *		
Category	Supplemental			GPS Latitude/Longitude		
				Start	End	
Item	2017 Storm Damage			38.478089 °	38.478050 °	
				-121.542623 °	-121.542581 °	
DWR ID	LMA-69					
Comment Code						
Inspector Comment						
Levee Evaluation Comments						
Description:						
Site ID No:236						
Site Designation:LMA-69						
Repair Type: Erosion						
Rating: Area of Concern						
Field Date:6/7/2017						
Notes: upper waterside levee slope erosion appeared caused from runoff from paved crown and foot traffic

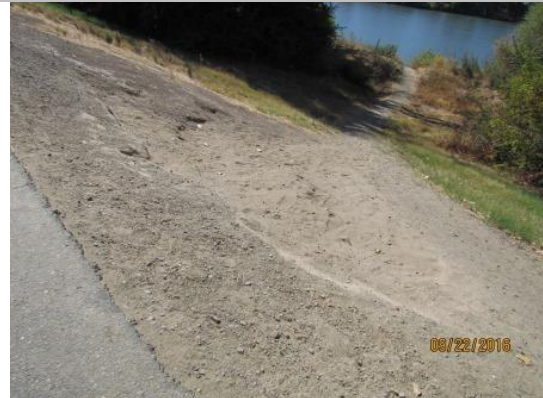
Photo 1 of 3 : FA\_2019\_MA0009\_201\_301\_20190904\_00208.jpg

LM Start	6.53	Rating **	M	Issue No.	301
LM End	6.53	Issue Type +	Ma	Location *	WS
Category	Earthen Levee			GPS Latitude/Longitude	
				Start	End
Item	Slope Stability			38.477116°	38.477116°
				-121.541253°	-121.541253°
DWR ID	DWR_MA0009_01_s_2015_301				
Comment Code					
S2 : Repair the levee slope damaged by foot traffic and prevent access where possible.					
Inspector Comment					
Footpath on waterside slope.

An updated view of slope stability site. Waterward side of the levee. Fall 2016.

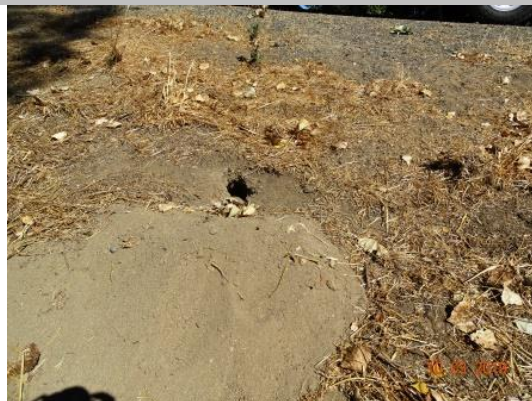
Photo 1 of 1 : FA\_2019\_MA0009\_201\_203\_20191008\_00529.jpg

LM Start	6.68	Rating **	M	Issue No.	203
LM End	6.68	Issue Type +	Ma	Location *	WS
Category	Earthen Levee			GPS Latitude/Longitude	
				Start	End
Item	Animal Control			38.475938 °	38.475938 °
				-121.539030 °	-121.539030 °
DWR ID	DWR_MA0009_01_f _ 2019_203				
Comment Code					
A3 : No rodents visible, but rodent burrows visible; need to backfill and compact or grout burrows.					
Inspector Comment					
Backfill animal hole with recent activity.

View of animal hole that appears to have recent activity. Fall 2019

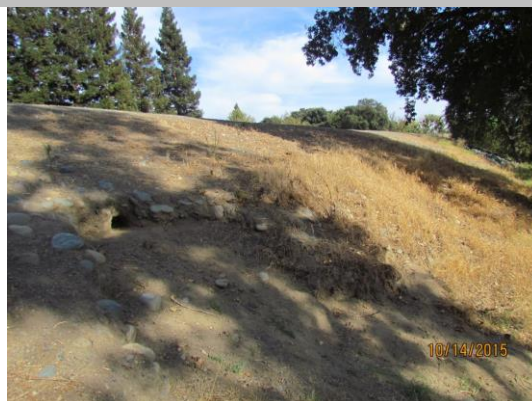
Photo 1 of 1 : FA\_2019\_MA0009\_201\_341\_20190904\_00246.jpg

LM Start	6.68	Rating **	A/W	Issue No.	341
LM End	6.68	Issue Type +	Ma	Location *	WS
Category	Earthen Levee			GPS Latitude/Longitude	
				Start	End
Item	Slope Stability			38.475921 °	38.475921 °
				-121.539017 °	-121.539017 °
DWR ID	DWR_MA0009_01_f_2015_341				
Comment Code					
S2 : Repair the levee slope damaged by foot traffic and prevent access where possible.					
Inspector Comment					
Footpath on landside slope.

View of the slope stability issue caused by foot traffic on the waterward side of the levee looking downstream. Fall 2015.

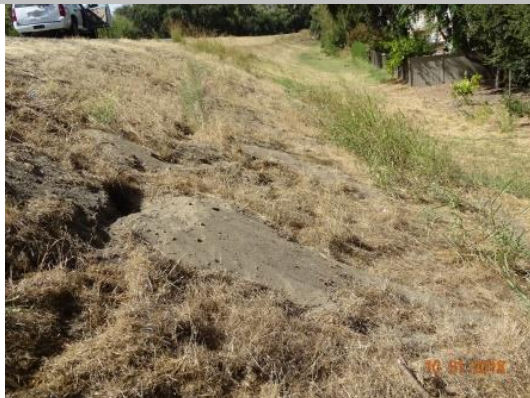
Photo 1 of 3 : FA\_2019\_MA0009\_201\_418\_20190904\_00279.jpg

View of rodent holes still exist on landside slope. Fall 2018

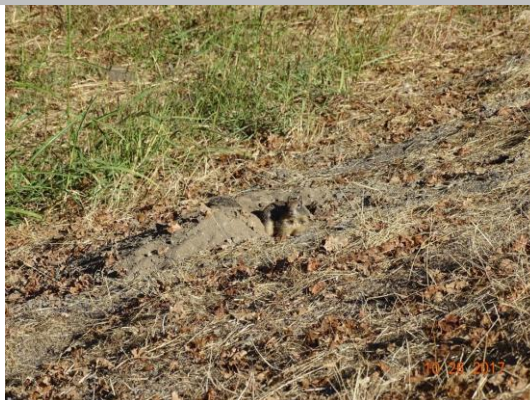
Photo 2 of 3 : FA\_2019\_MA0009\_201\_418\_20190904\_00280.jpg

View of squirrel in hole on landside slope. Fall 2017.

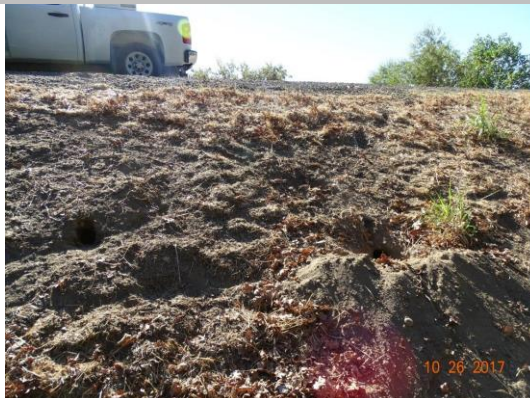
Photo 3 of 3 : FA\_2019\_MA0009\_201\_418\_20190904\_00281.jpg

Additional view of holes on landside slope. Fall 2017.

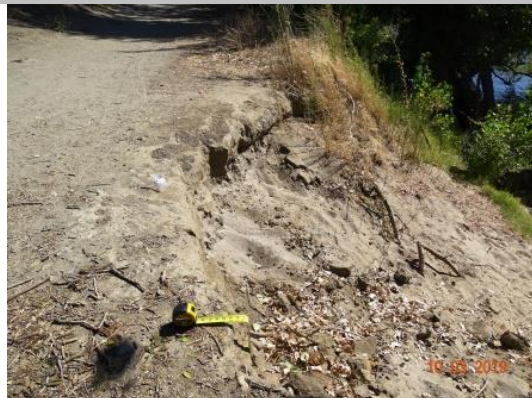
Photo 1 of 3 : FA\_2019\_MA0009\_201\_267\_20191008\_00530.jpg

LM Start	6.89	Rating **	M	Issue No.	267
LM End	6.89	Issue Type +	Ma	Location *	
Category	Supplemental			GPS Latitude/Longitude	
				Start	End
Item	2017 Storm Damage			38.474828 °	38.474828 °
				-121.535455 °	-121.535455 °
DWR ID	MA9-03				
Comment Code					
Inspector Comment					
Levee Evaluation Comments					
Description:					
Site ID No:56					
Site Designation:MA9-03					
Repair Type: Erosion					
Rating: Area of Concern					
Field Date:5/18/2017					
Notes: This site was visited but no data was recorded at the time. The Sac Yard is planning on repairing this site by the end of November this year. Erosion cuts into WS toe road, but is not within the prism. Fall 2019 DWR Inspection: The cut into the WS toe road is almost 2' deep.

View of erosion on waterside berm road. Fall 2019

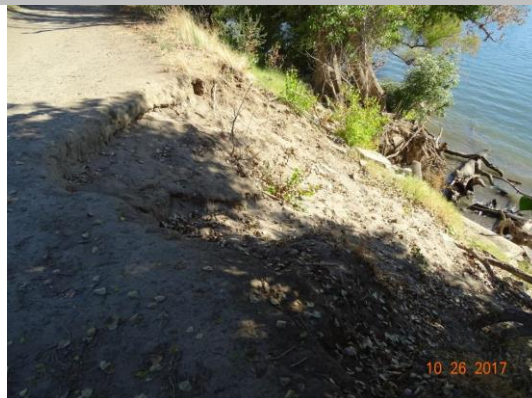
Photo 2 of 3 : FA\_2019\_MA0009\_201\_267\_20190904\_00188.jpg

View of erosion on berm road. Fall 2017.

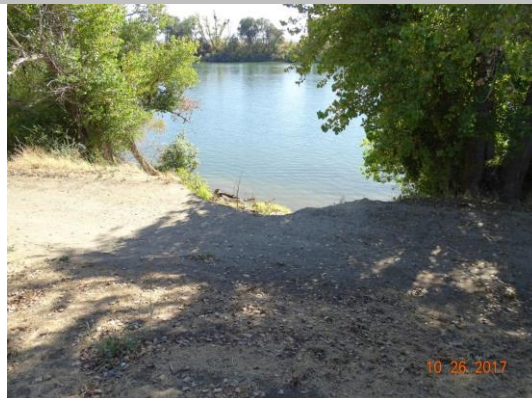
Photo 3 of 3 : FA\_2019\_MA0009\_201\_267\_20190904\_00189.jpg

LM Start	6.89	Rating **	M	Issue No.	267 (cont)	
LM End	6.89	Issue Type +	Ma	Location *		
Category	Supplemental			GPS Latitude/Longitude		
				Start	End	
Item	2017 Storm Damage			38.474828 °	38.474828 °	
				-121.535455 °	-121.535455 °	
DWR ID	MA9-03					
Comment Code						
Inspector Comment						
Levee Evaluation Comments						
Description:						
Site ID No:56						
Site Designation:MA9-03						
Repair Type: Erosion						
Rating: Area of Concern						
Field Date:5/18/2017						
Notes: This site was visited but no data was recorded at the time. The Sac Yard is planning on repairing this site by the end of November this year. Erosion cuts into WS toe road, but is not within the prism. Fall 2019 DWR Inspection: The cut into the WS toe road is almost 2' deep.

Additional view of erosion. Fall 2017.

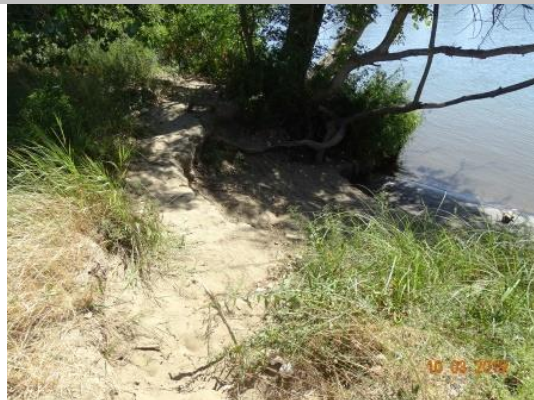
Photo 1 of 2 : FA\_2019\_MA0009\_201\_213\_20191008\_00531.jpg

LM Start	7.01	Rating **	A/W	Issue No.	213
LM End	7.28	Issue Type +	Ma	Location *	WS
Category	Supplemental			GPS Latitude/Longitude	
				Start	End
Item	2017 USACE Erosion Survey			38.474575 °	38.474733 °
				-121.533104 °	-121.528221 °
DWR ID	DWR_MA0009_01_s_2019_213				
Comment Code					
Inspector Comment					
2017 Site ID: SAC 48.4 L					
Status: Eroding New					
2017 Field Notes: New erosion along toe. Possibly part of pl 84-99 site					
Site History: 2016 - Extensive toe erosion. Erosion around roots of multiple trees.

View of erosion on waterside berm and around tree with exposed roots at approximately LM 7.05. Fall 2019

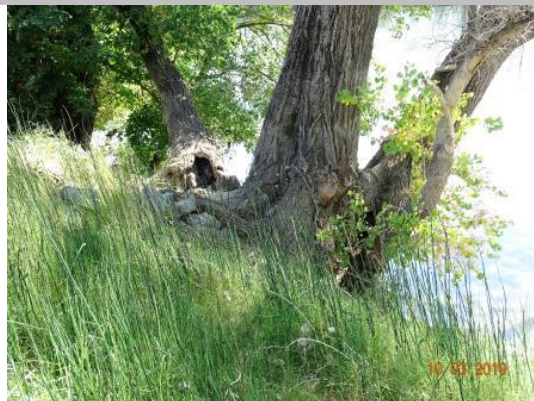
Photo 2 of 2 : FA\_2019\_MA0009\_201\_213\_20191008\_00532.jpg

View of erosion on waterside berm and around tree at approximately LM 7.21. Fall 2019

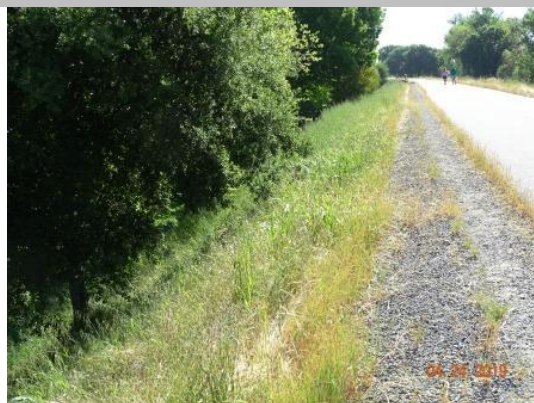
Photo 1 of 1 : FA\_2019\_MA0009\_201\_555\_20190904\_00297.jpg

LM Start	7.06	Rating **	M	Issue No.	555
LM End	7.18	Issue Type +	En	Location *	LS
Category	Earthen Levee			GPS Latitude/Longitude	
				Start	End
Item	Vegetation			38.474778 °	38.474830 °
				-121.532188 °	-121.530005 °
DWR ID	DWR_MA0009_01_s_2019_555				
Comment Code					
V6 : Landscaping					
Inspector Comment					
Property needs to trim trees that block the levee slope.

View looking downstream at trees that need to be trimmed. Spring 2019

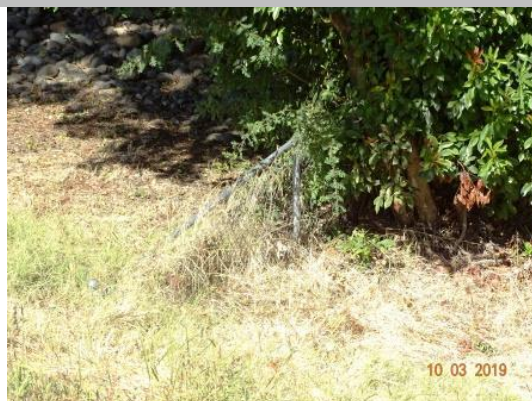
Photo 1 of 1 : FA\_2019\_MA0009\_201\_209\_20191008\_00533.jpg

LM Start	7.20	Rating **	M	Issue No.	209
LM End	7.20	Issue Type +	En	Location *	LS
Category	Earthen Levee			GPS Latitude/Longitude	
				Start	End
Item	Encroachments			38.474857 °	38.474857 °
				-121.529663 °	-121.529663 °
DWR ID	DWR_MA0009_01_f_2019_209				
Comment Code					
FE : Fence					
Inspector Comment					
A metal pipe barrier runs perpendicular to the levee.

View of metal pipe barrier perpendicular to the levee. Fall 2019

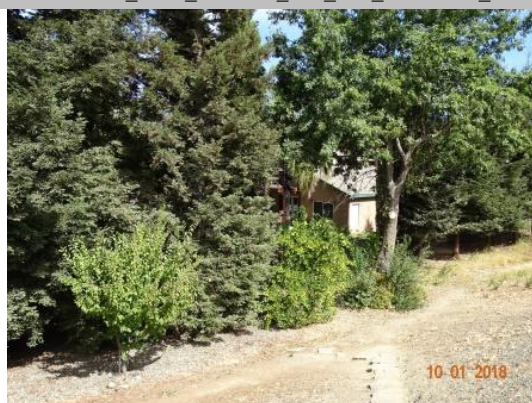
Photo 1 of 2 : FA\_2019\_MA0009\_201\_158\_20190904\_00084.jpg

LM Start	7.25	Rating **	M	Issue No.	158
LM End	7.25	Issue Type +	En	Location *	LS
Category	Earthen Levee			GPS Latitude/Longitude	
				Start	End
Item	Vegetation			38.474861 °	38.474861 °
				-121.528804 °	-121.528804 °
DWR ID	DWR_MA0009_01_s_2019_158				
Comment Code					
V6 : Landscaping					
Inspector Comment					
Fruit tree and landscaping appear to be within the levee toe easement.

View of landscaping and fruit tree near levee toe. Fall 2018

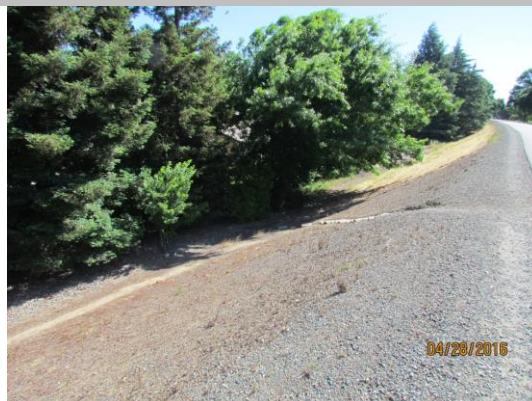
Photo 2 of 2 : FA\_2019\_MA0009\_201\_158\_20190904\_00085.jpg

View of the landscaping on the landward side of the levee looking downstream. Landscape is borderline at easement of toe. Spring 2016.

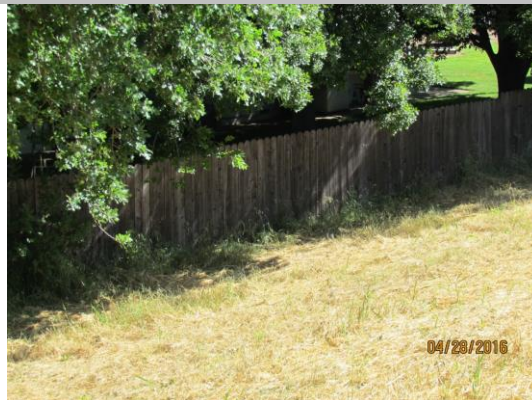
Photo 1 of 2 : FA\_2019\_MA0009\_201\_162\_20190904\_00090.jpg

LM Start	7.44	Rating **	U	Issue No.	162
LM End	7.44	Issue Type +	En	Location *	LS
Category	Earthen Levee			GPS Latitude/Longitude	
				Start	End
Item	Encroachments			38.475156 °	38.475156 °
				-121.525212 °	-121.525212 °
DWR ID	DWR_MA0009_01_s_2012_162				
Comment Code					
FE : Fence					
Inspector Comment

A wooden fence is near the toe of the levee. Spring 2016.

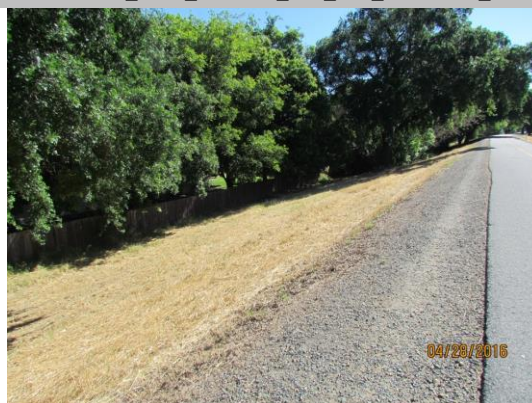
Photo 2 of 2 : FA\_2019\_MA0009\_201\_162\_20190904\_00091.jpg

Perspective view of the wooden fence on the landward side of the levee looking downstream. Spring 2016.

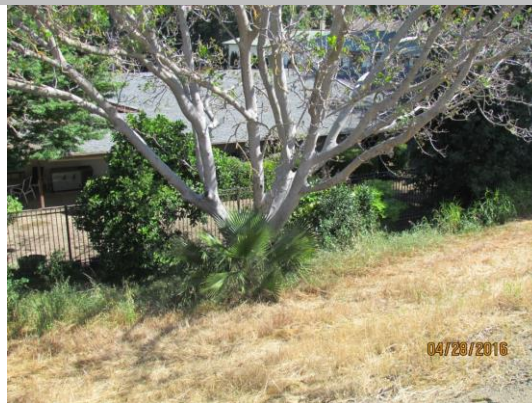
Photo 1 of 1 : FA\_2019\_MA0009\_201\_163\_20190904\_00092.jpg

LM Start	7.48	Rating **	M	Issue No.	163
LM End	7.49	Issue Type +	En	Location *	LS
Category	Earthen Levee			GPS Latitude/Longitude	
				Start	End
Item	Vegetation			38.475227 °	38.475249 °
				-121.524477 °	-121.524312 °
DWR ID	DWR_MA0009_01_s_2012_163				
Comment Code					
V6 : Landscaping					
Inspector Comment					
Remove palm trees from levee toe.

View of the trees and shrub at the toe of the levee. Spring 2016.

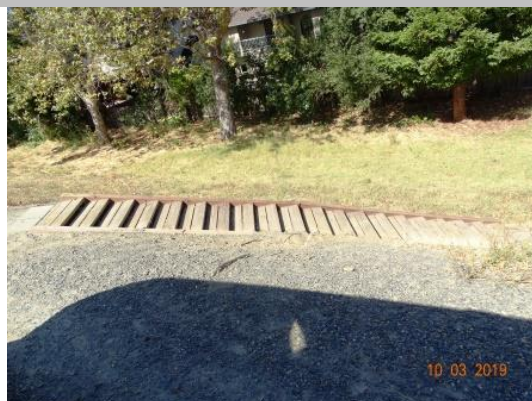
Photo 1 of 1 : FA\_2019\_MA0009\_201\_324\_20191008\_00536.jpg

LM Start	7.80	Rating **	M	Issue No.	324
LM End	7.80	Issue Type +	En	Location *	LS
Category	Earthen Levee			GPS Latitude/Longitude	
				Start	End
Item	Encroachments			38.475485 °	38.475485 °
				-121.518697 °	-121.518697 °
DWR ID	DWR_MA0009_01_f_2018_324				
Comment Code					
ST : Stairway					
Inspector Comment					
A wooden stairway is installed on the landside slope.

View of wooden stairs on the landside slope. Fall 2019

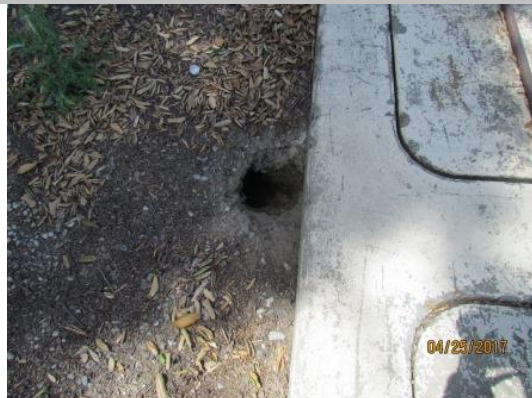
Photo 1 of 1 : FA\_2019\_MA0009\_201\_290\_20190904\_00197.jpg

LM Start	8.60	Rating **	A/W	Issue No.	290
LM End	8.60	Issue Type +	Ma	Location *	LS
Category	Earthen Levee			GPS Latitude/Longitude	
				Start	End
Item	Animal Control			38.471886 °	38.471886 °
				-121.504999 °	-121.504999 °
DWR ID	DWR_MA0009_01_f_2019_290				
Comment Code					
A1 : Exterminate rodents and backfill and compact or grout burrows.					
Inspector Comment					
Rodent hole within landside shoulder.

View of rodent hole on landside shoulder. Spring 2017.

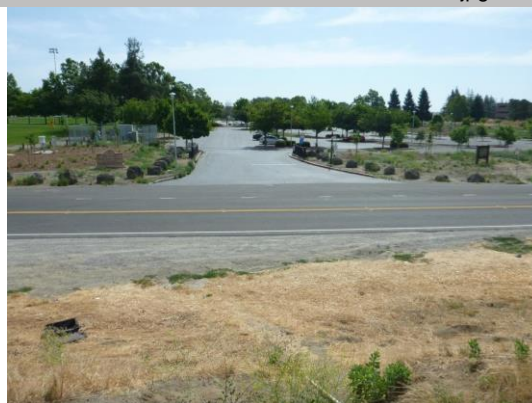
Photo 1 of 3 : LEVAL\_FA\_2019\_237\_523.jpg

LM Start	8.68	Rating **	A/W	Issue No.	269
LM End	8.68	Issue Type +	Ma	Location *	
Category	Supplemental			GPS Latitude/Longitude	
				Start	End
Item	2017 Storm Damage			38.471157°	38.471131°
				-121.503889°	-121.503884°
DWR ID	LMA-70				
Comment Code					
Inspector Comment					
Levee Evaluation Comments					
Description:					
Site ID No:237					
Site Designation:LMA-70					
Repair Type: Erosion					
Rating: Area of Concern					
Field Date:6/7/2017					
Notes: landside levee slope damage from foot traffic; no cross section taken; photo only, at this location levee has over 138' crown width; crown width relates to the landside railroad trails.

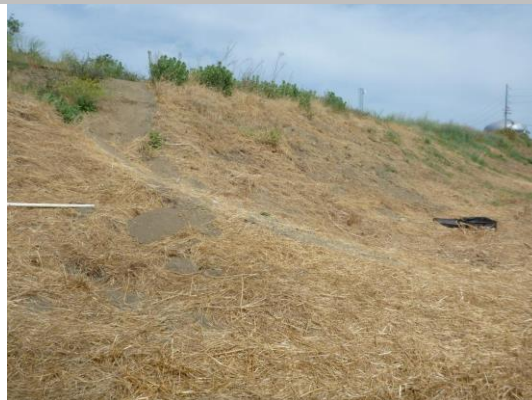
Photo 2 of 3 : LEVAL\_FA\_2019\_237\_526.jpg

LM Start	8.68	Rating **	A/W	Issue No.	269 (cont)
LM End	8.68	Issue Type +	Ma	Location *	
Category	Supplemental			GPS Latitude/Longitude	
				Start	End
Item	2017 Storm Damage			38.471157°	38.471131°
				-121.503889°	-121.503884°
DWR ID	LMA-70				
Comment Code					
Inspector Comment					
Levee Evaluation Comments					
Description:					
Site ID No:237					
Site Designation:LMA-70					
Repair Type: Erosion					
Rating: Area of Concern					
Field Date:6/7/2017					
Notes: landside levee slope damage from foot traffic; no cross section taken; photo only, at this location levee has over 138' crown width; crown width relates to the landside railroad trails.

View of slope damage from foot traffic.
